MOUNTAIN SPRINGS LAKE DAM

NDI ID NO. PA-00770
DER ID NO. 45-42

PHASE I INSPECTION REPORT
NATIONAL DAM INSPECTION PROGRAM

JANUARY 1980

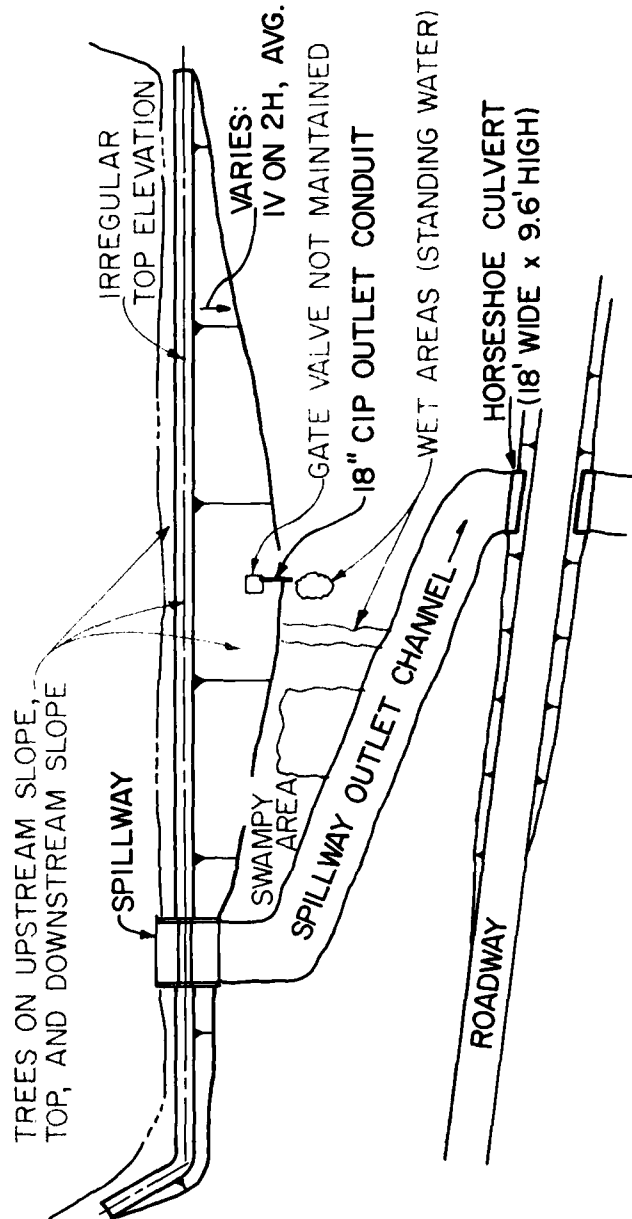
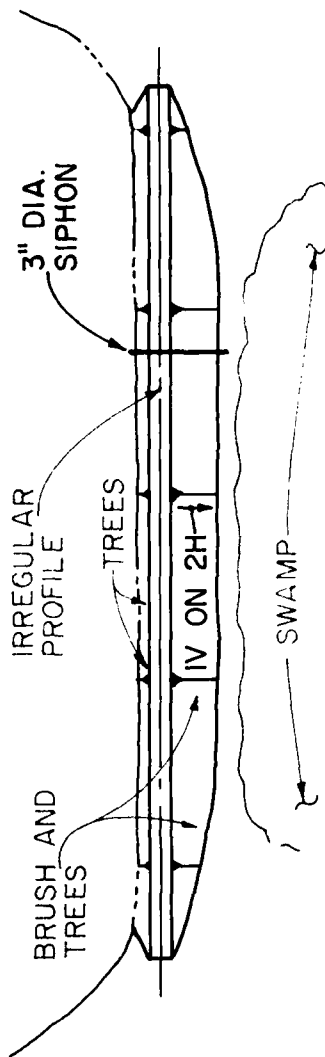
PLAN - DAM
NOT TO SCALE

b. Dam and Dike. Most of the upstream slope of the dam was submerged and could not be surveyed or inspected. The riprap appears to be in good condition. It extends to the top of the dam. The upstream slope, top, and downstream slope are overgrown with trees having an average diameter of 4 to 6 inches (Photographs A and B). Except for the trees, the downstream slope of the embankment is in satisfactory condition. Two wet areas were observed at the toe of the dam. Although standing water was present, no flow was visible. A large swampy area, which did not have significant amounts of standing water, was also located in the area downstream from the toe of the dam. The approximate locations and extents of the wet areas and the swampy area are shown on Exhibit B-1.
